Views from a surveyor

Paul Hill – Global Technical Director, Maritime

Engine room fires - update

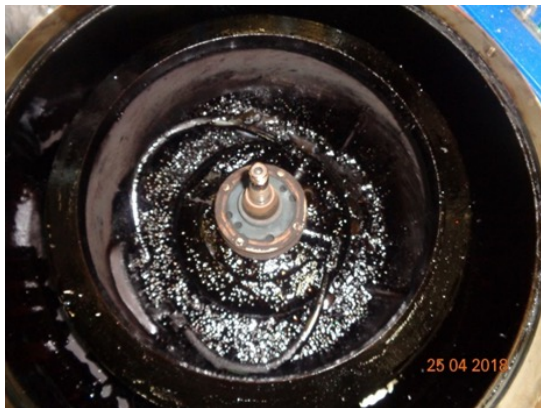
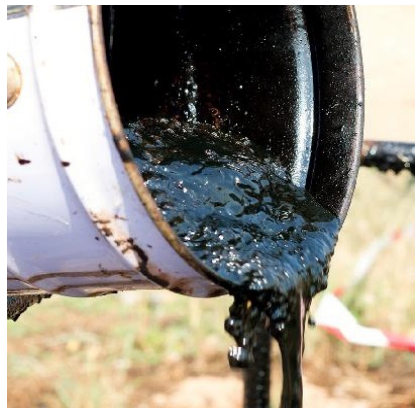
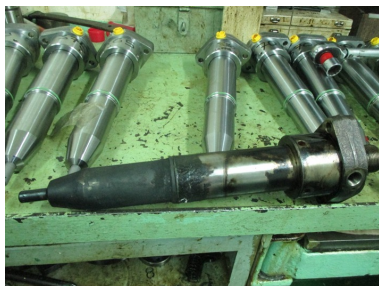
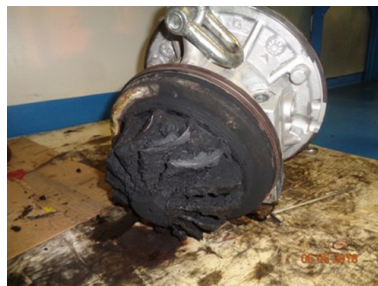
Incompatibility – Sludge formation

Sludging caused by unstable fuels is one of the most serious operational concerns

Each new batch can be materially different and hence incompatible with other fuels onboard

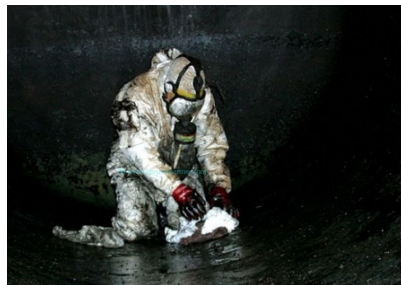
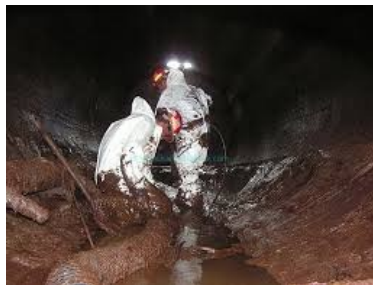
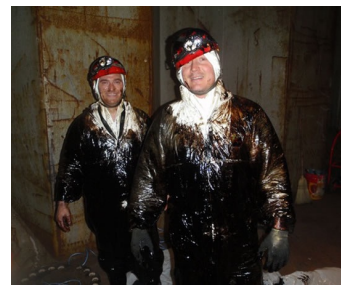
Incompatibility – Sludge formation

Not limited to engine damage but also includes

- **Disposal of contaminated bunkers**
- **Cleaning of fuel tanks**
- **Disposal of sludge**

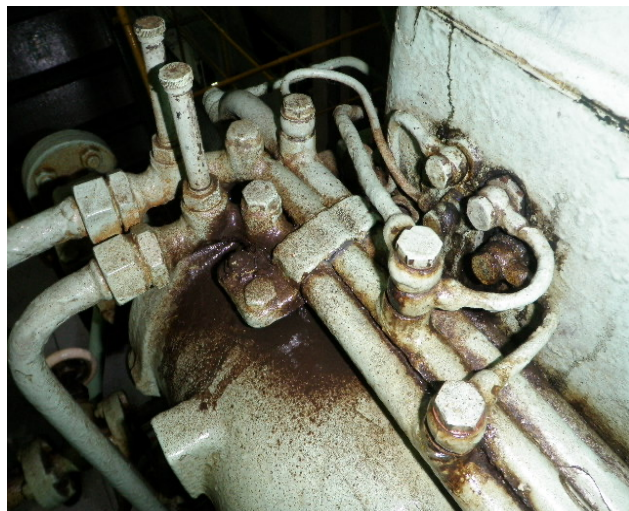
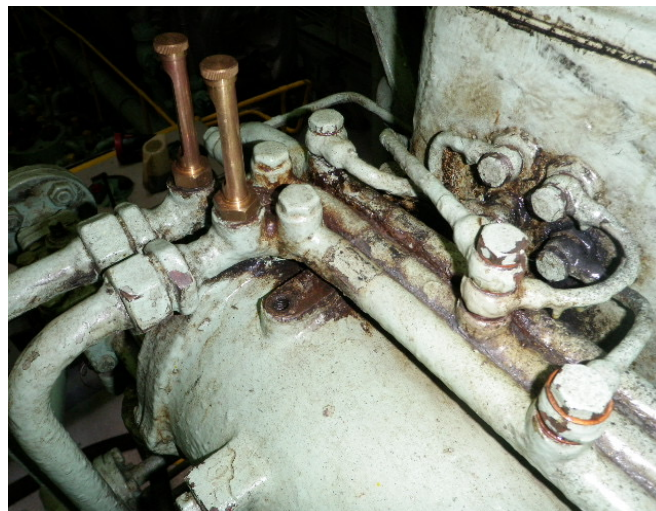
HIGH PRESSURE FUEL INJECTION PIPE BRACKETS

with

without

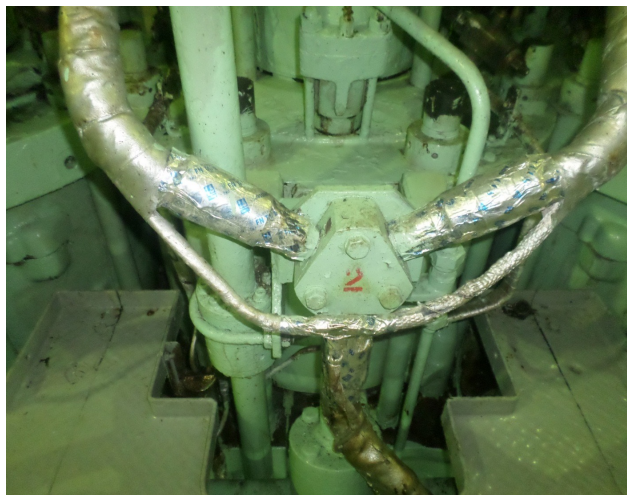
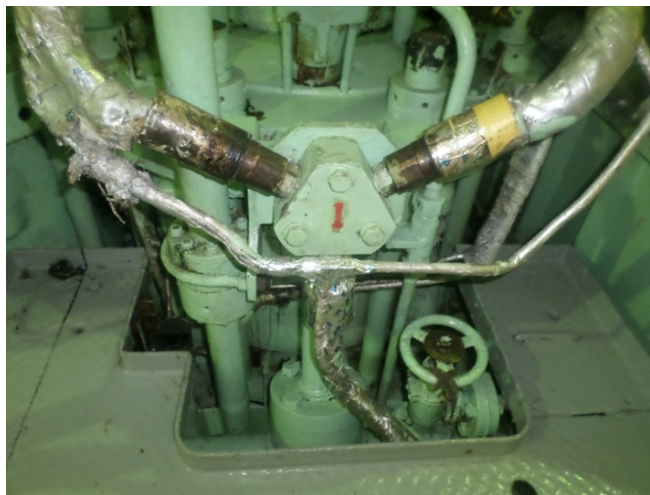
HIGH PRESSURE FUEL INJECTION PIPE – WITH “SOLAS” TAPE

with

without

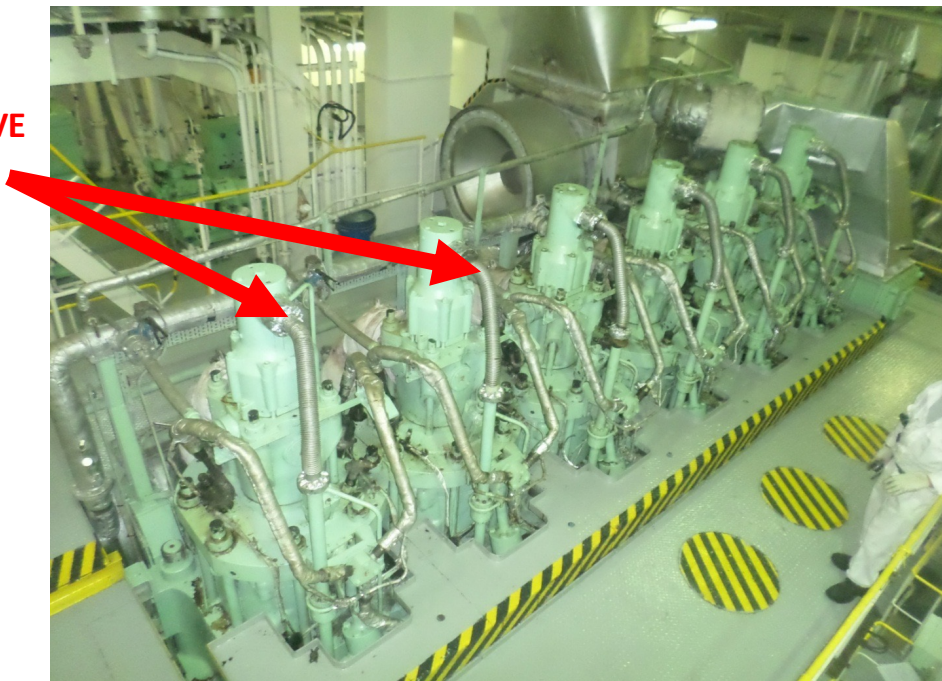
HYDRAULIC EXHAUST VALVE ACTUATORS

**EXHAUST VALVE
ACTUATORS**

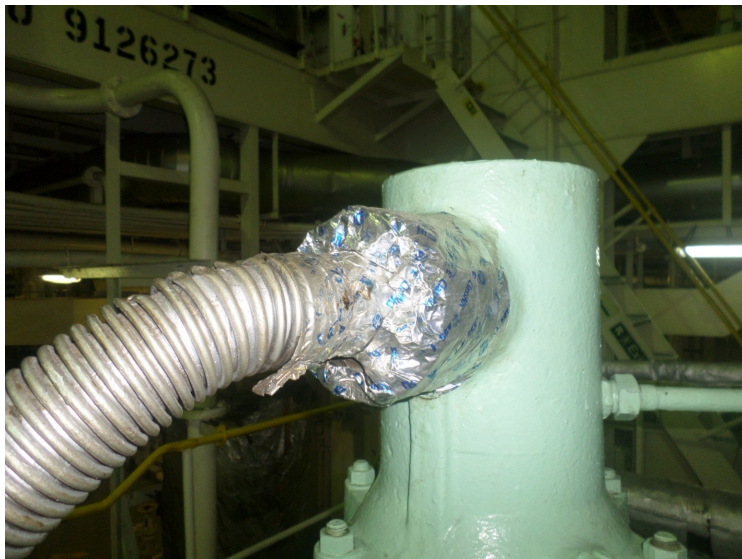
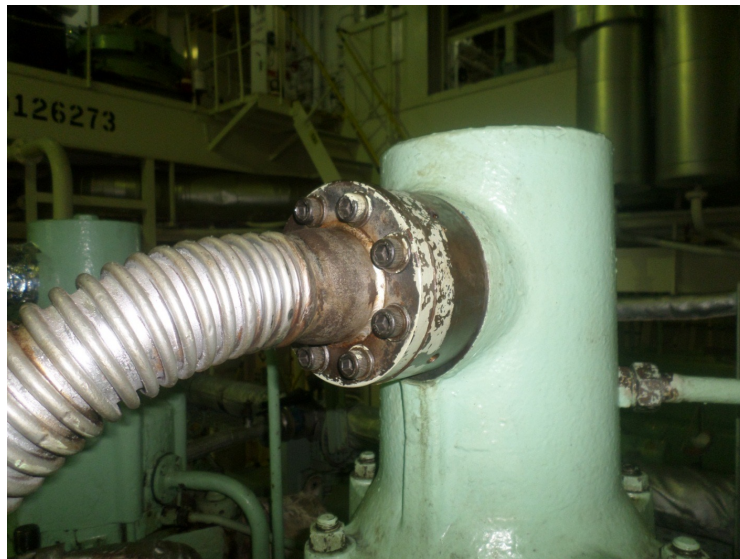
EXHAUST ACTUATOR – PROTECTED WITH “SOLAS” TAPE

with

without

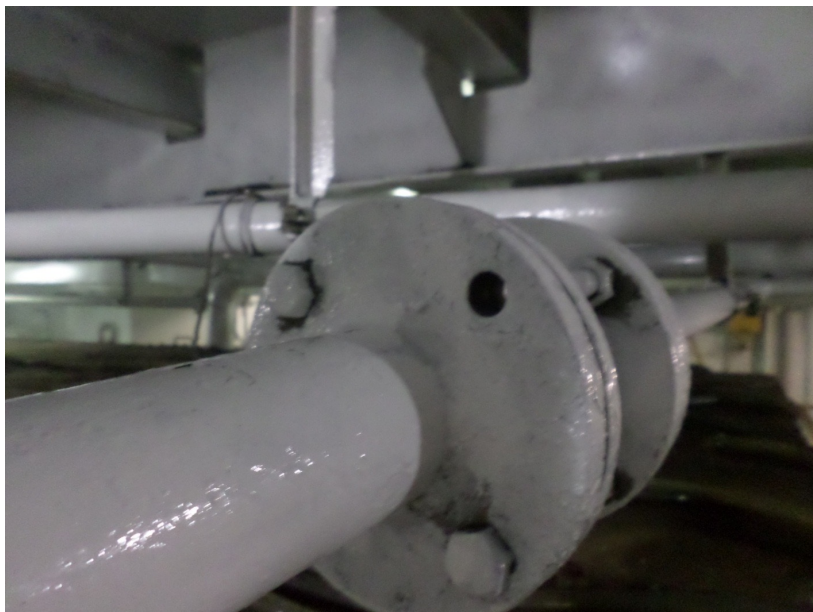
LOW PRESSURE (L.P) FUEL & LUBRICATING OIL PIPES

**Bolts missing and
no splash tape**

The rules do not apply to low pressure (LP) piping

LP fuel pipework is an item on the IUMI Policy Agenda and is currently being addressed with IACS

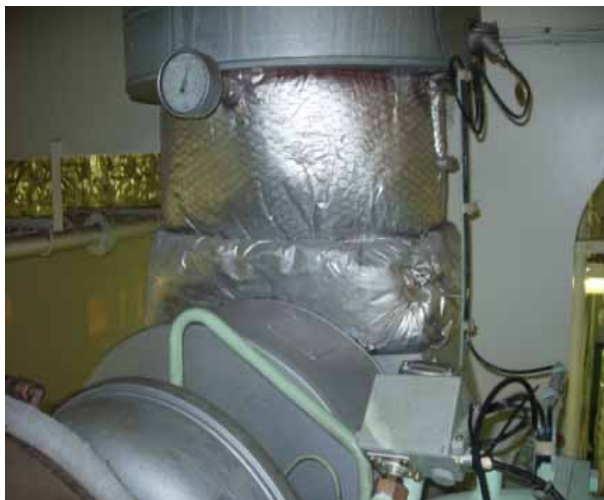
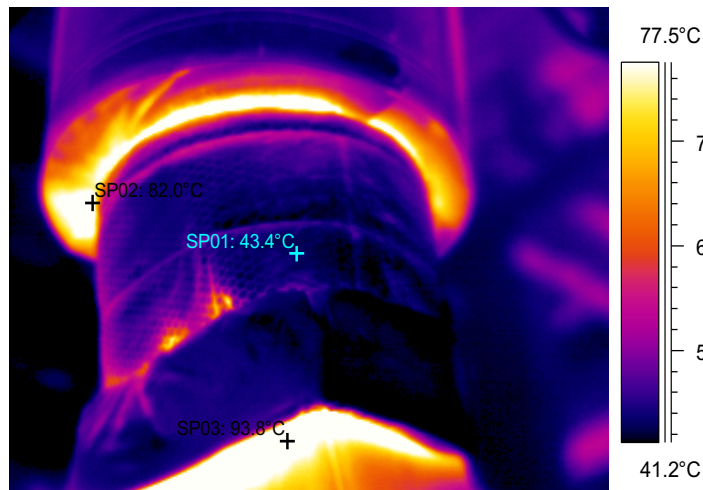
A VIEW OF A TYPICAL DIESEL ENGINE EXHAUST UPTAKE CORRECTLY LAGGED

TEMPERATURES ARE WELL WITHIN THE SOLAS LIMITS

According to IACS rules and after 1998, and as also stated in SOLAS Ch II-2 Reg.15.2.10, all surfaces above 220°C must be insulated or protected in order to prevent ignition of flammable fluids.

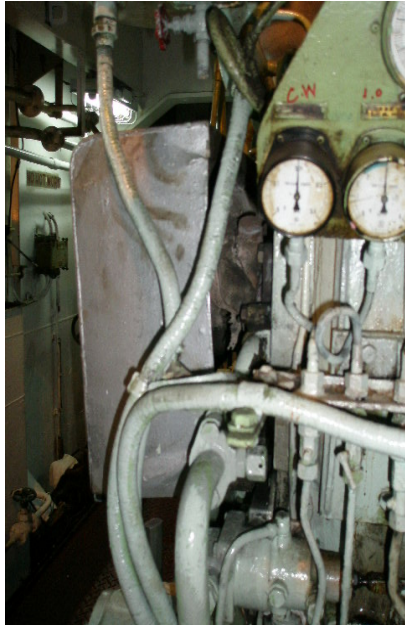
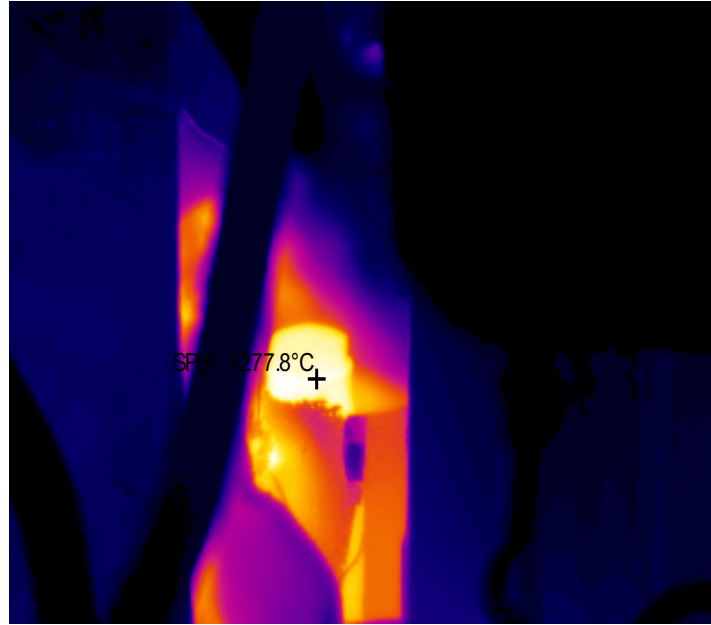
TYPICAL DIESEL ENGINE EXHAUST UPTAKE INCORRECTLY LAGGED

A THERMOMETER POCKET IS EXPOSED
